INSPECTION REPORT
UWF EH&S

Inspection type: Water Intrusion & Odor Report No. 061212-B4 (S&E)
Inspector: Pennie Sparks Contact Information: (850) 474-2177 psparks@uwf.edu
Date: 06/11/12 Time: 10:30am & 4:00pm Facility: Building 4 Science & Engineering
Room: 1st Floor Lobby and Halo deck

Inspection type: Tile Issues Report No. 061712-B54 (Pool)
Inspector: Pennie Sparks Contact Information: (850) 474-2177 psparks@uwf.edu
Date: 06/27/12 Time: 9:00 am Facility: Building 73 Pool
Room: Pool deck

Inspection type: Safety Report No. IR10151201
Inspector: Pennie Sparks Contact Information: (850) 474-2177 psparks@uwf.edu
Date: 10/15/12 Time: 3:00 pm Facility: Building 13
Room: Outside

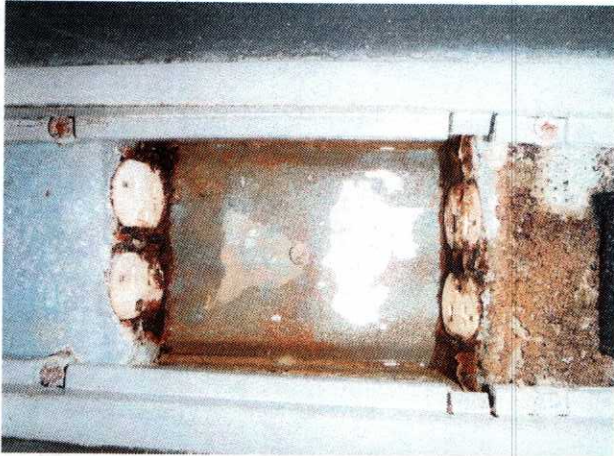
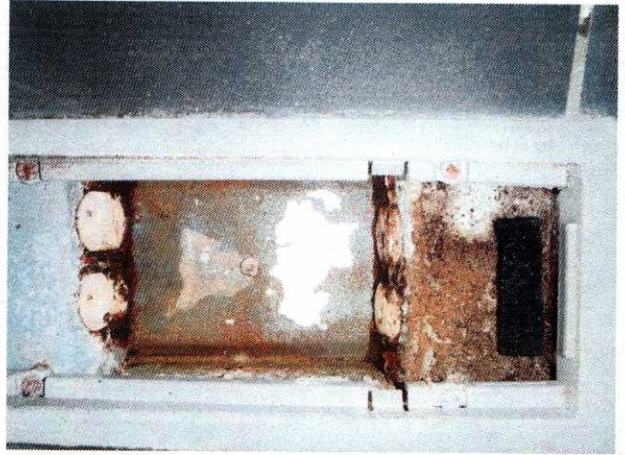
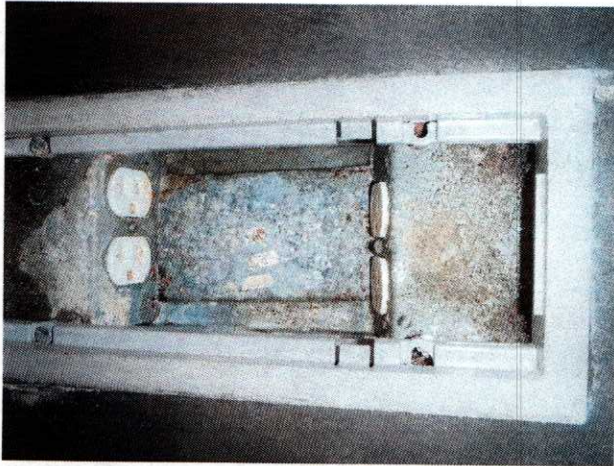
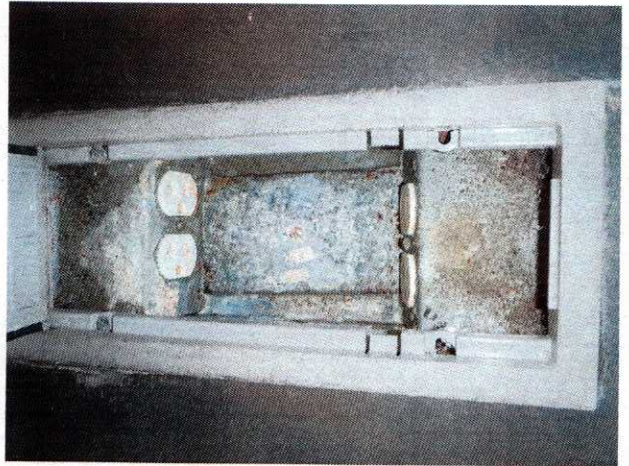
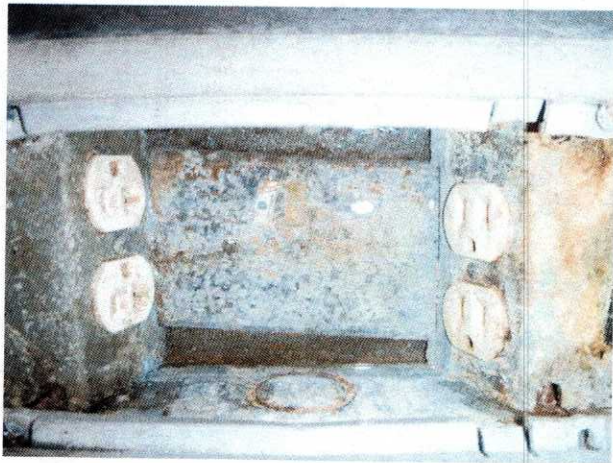
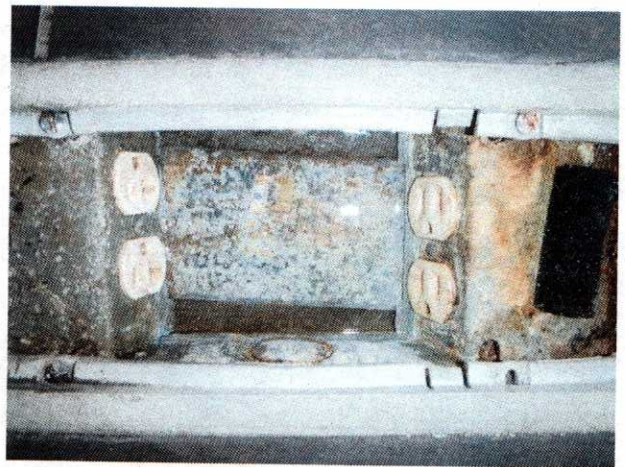
EH&S responded to a request from building managers, Cliff Redding and David Algeo to evaluate water intrusion in the 1st floor lobby, specifically in the floor mounted power outlets and an odor emanating from the wet outlets. Upon entering the building I observed the outlet covers (3) propped open and a fan running, but did not notice any obvious odor. I met with Cliff and David and discussed their concerns. They stated that when they entered the building early in the morning building services personnel were mopping the floor around the outlets and the power was still on/energized. The power was turned off at the breaker and the water vacuumed out of the power boxes. I observed a small amount of water still present inside the boxes and corrosion around the outlets (see attached photos). By the time I arrived, the odor had dissipated however, it was described as a musty/moldy smell. Water intrusion in the halo deck room was also observed along and out from the screen wall in a half moon shape, approximately 12' x 6'. There appeared to be evidence of previous water intrusion at the windows in the entry way to the halo deck.

I conducted a visual assessment of the 1st floor lobby, power boxes and the halo deck room looking for moisture intrusion. Weather stripping at the bottom of the doors was intact and did not appear to be damaged or malformed. Photos were taken of the power boxes and outlets. There were obvious signs of past moisture problems in the power boxes and around the outlets. A V-ray instrument was used to determine if any volatile organic compounds (VOC) were being released from the outlet boxes which could account for the odor that was detected by building staff. The instrument detected an average of 122 ppb VOC in the most corroded box and an average of 94 ppb VOC in the other two boxes. At this low level, the VOC are negligible and probably is not the source of the odor.

The infra-red camera that I was using for surveying moisture detected a very wet carpet in the holodeck room, however, moisture was not detected in the wall at that time. The area around the windows in the entry way did not show any current intrusion of moisture but as previously stated there was evidence of a previous moisture intrusion.

Recommended the area be wet vacuumed again until as much water is removed as possible and fans be placed in the room to dry the area to help prevent wicking of the moisture up into the wall and causing further damage.

1. Lock-out/tag-out breaker for floor mounted outlets or completely remove breaker/power source from the outlets. **Power must be secured** in some manner so that it cannot be accidently re-engenerized until a more permanent solution can be reached.

2. Determine permanent solution for preventing water from entering floor mounted power boxes.

Suggest - remove power and cover power boxes with closed plate

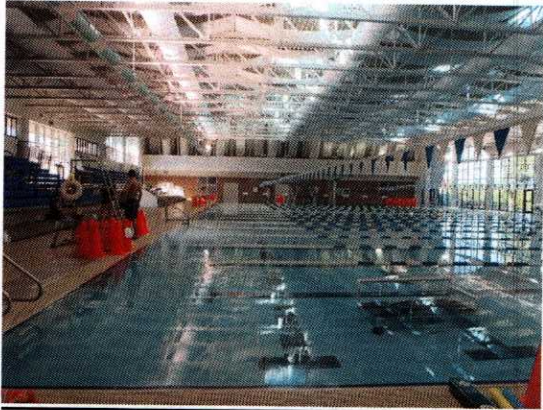
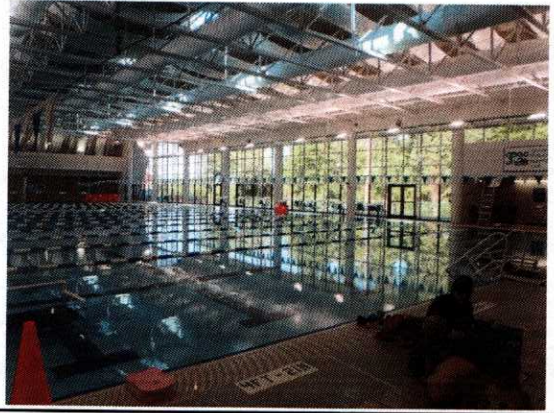
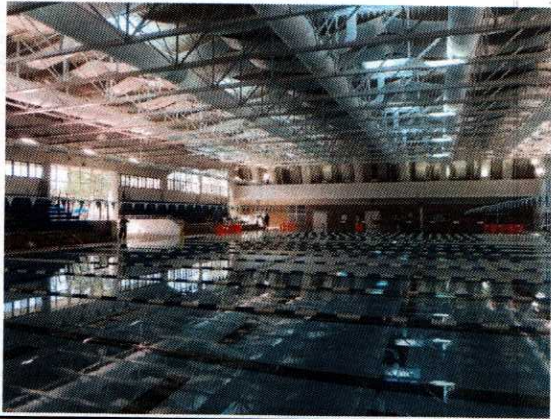
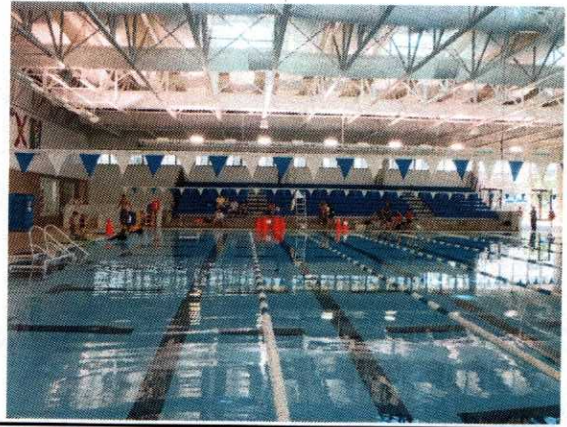
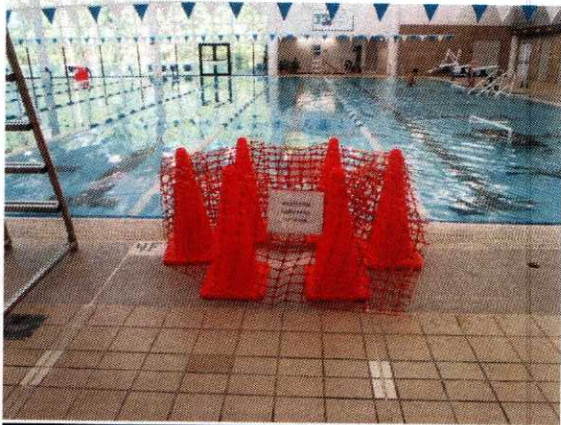
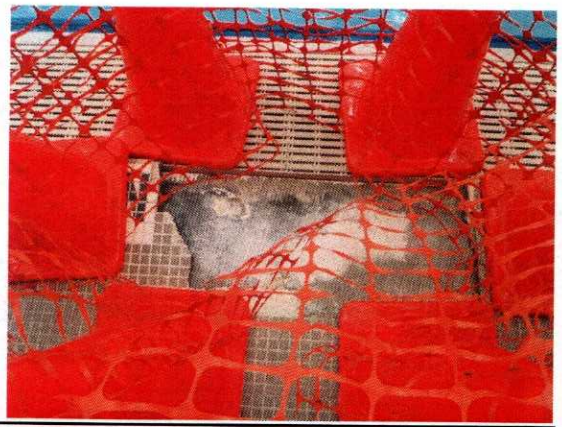
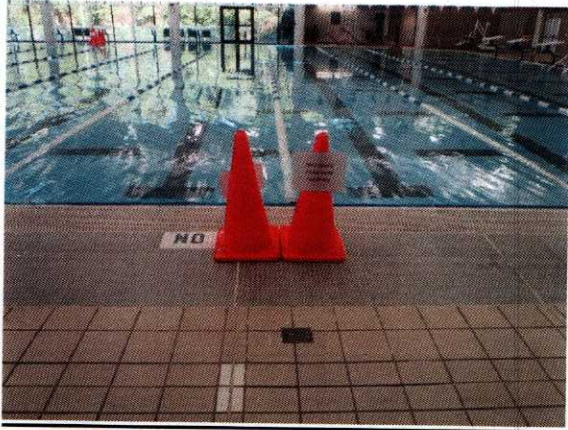
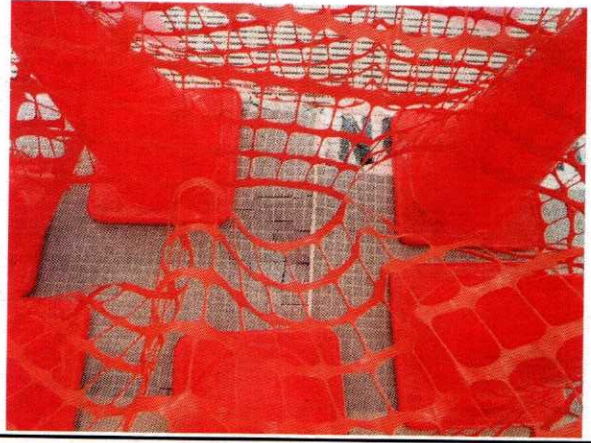
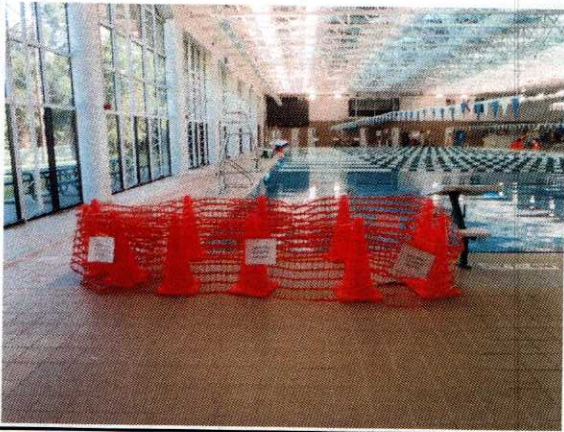
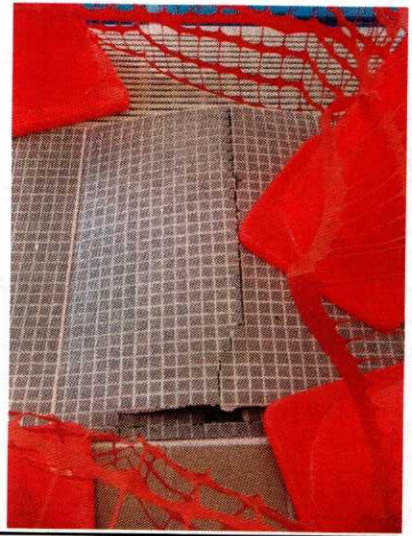
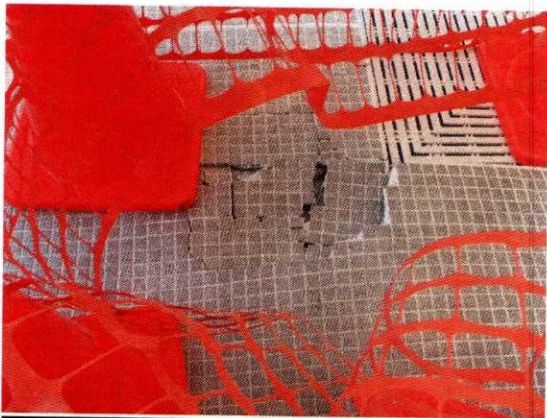
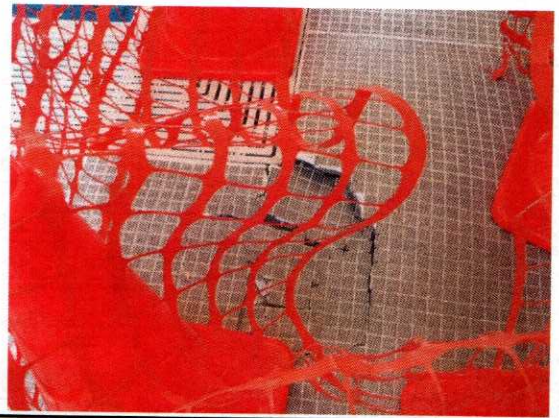
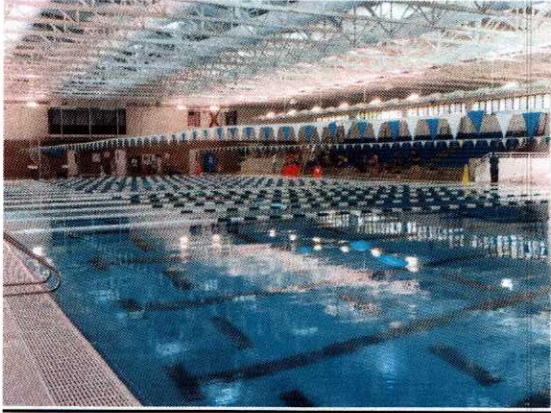
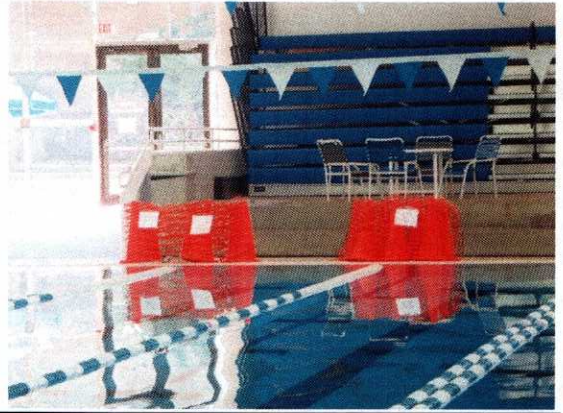
Document tile issues and safety barriers around pool deck. Large red cones and/or fencing have been placed around all areas where the tile is broken, raised or in some way damaged which could create a safety issue for those working or visiting the pool. These areas appear to be sufficiently marked and/or blocked to prevent injuries from occurring because of the damaged tile.

- 1. Maintain barriers until a more permanent resolution is achieved .**
- 2. Tile should be repaired/replaced as soon as reasonable; possibly between summer and fall semester.**

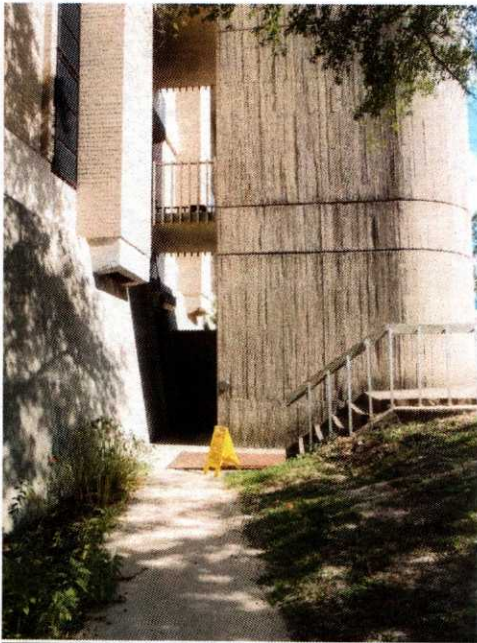
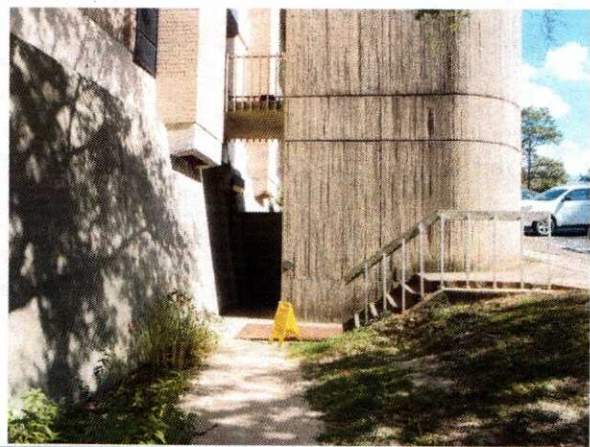
A possible safety issue was reported by a building occupant. The occupant described a washed out area under the sidewalk near the stairs that has created a large hole. They had placed a wet floor sign next to the area but not covering the hole. The area was surveyed, measured and photographed (see attached). A large orange hazard cone was placed over the hole and the wet floor sign was moved to the bottom of the stairs to warn of the danger. The hole is located at the corner of two sections of concrete at the bottom of the outside stairs leading to stairway 100C. It is approximately thirteen inches deep, eleven inches long and six inches wide. The soil is caving in on either side of the existing hole, which if not corrected will create an even bigger hazard to pedestrian traffic in the area.

The existing hole is large enough that if someone stepped in it they could easily break a leg. Therefore, a temporary and long term solution should be reached to rectify the situation as soon as possible.

1. Fill existing washout hole with adequate fill to prevent future re-occurrence.
2. Provide erosion control to the entire area. One solution is to plant the hill with

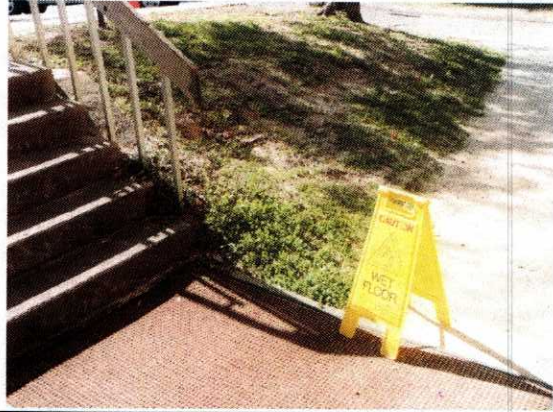
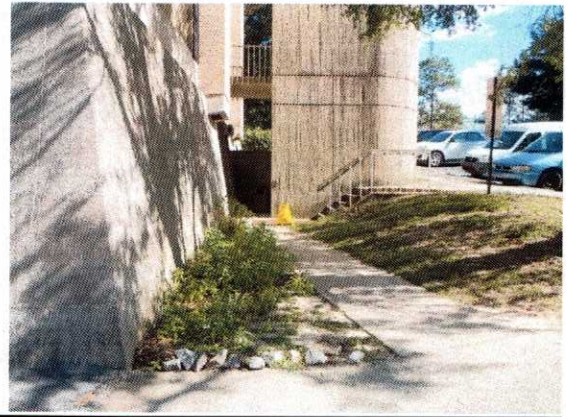
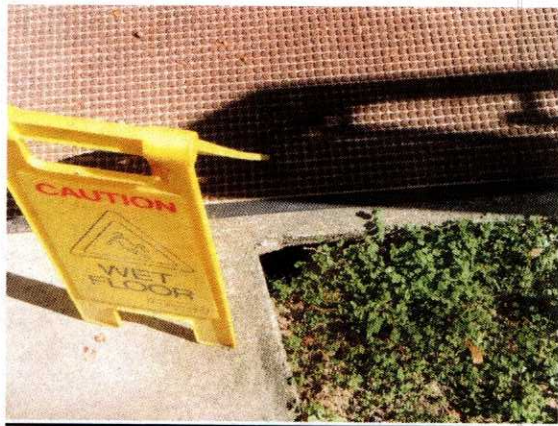
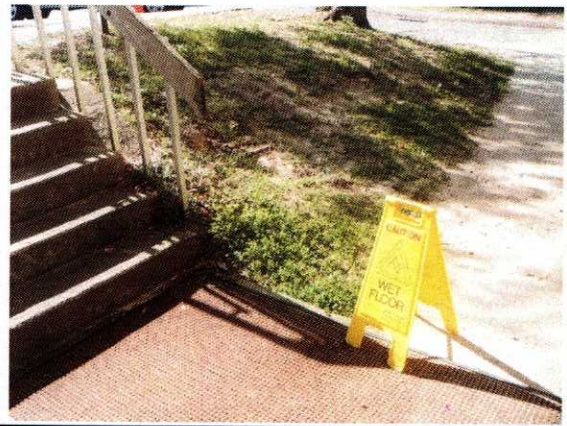
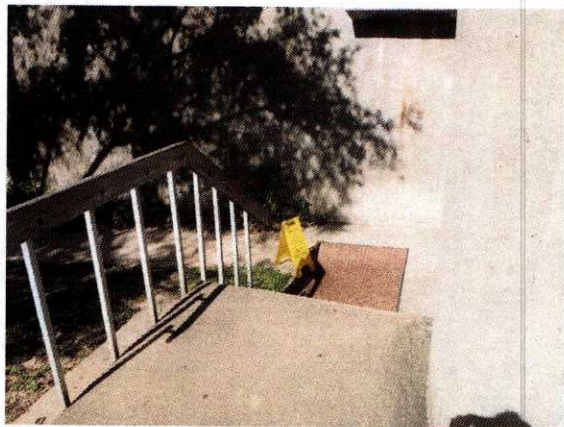
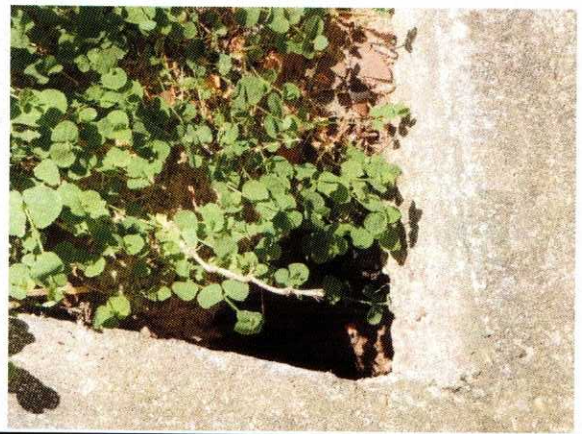
The hill/slope next to the stairs and above the sidewalk is also eroding away with fairly deep ruts (see attached photo). This area appears to be heavily traveled and should be considered in the long term solution to the existing problems. Also, the entrance to the service road and the service road itself is in dire need of repair. The asphalt is mounded on the edge of the entrance and deep cracks exist in the asphalt. Since this road is used as a pedestrian pathway to access the nature trail by university faculty, staff, students and the public, it should be maintained to a satisfactory level of safety.

erosion controlling plants such as running juniper with landscape liner/fabric placed between the plants. This should stabilize the hill and help prevent future erosion. In addition, diverting the runoff to another area would help with long term stability of the entire area.
