**Analysis of Fecal Loadings  
Into Bayous Grande, Chico, and Texar  
Pensacola Bay System, FL**

12 September 2006

Prepared for:  
Florida Department of Health  
Escambia County Health Department

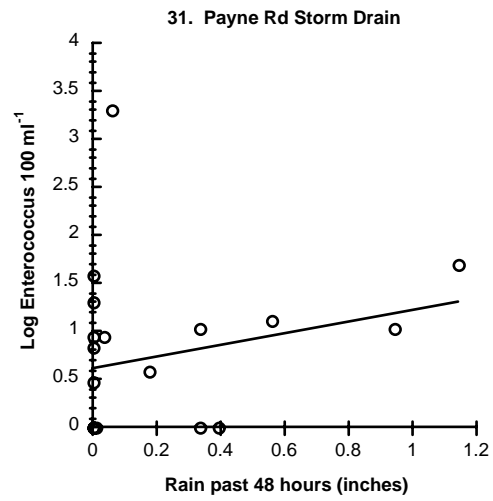
Figure 11. Station-specific analysis of rainfall dependence in Bayou Grande.

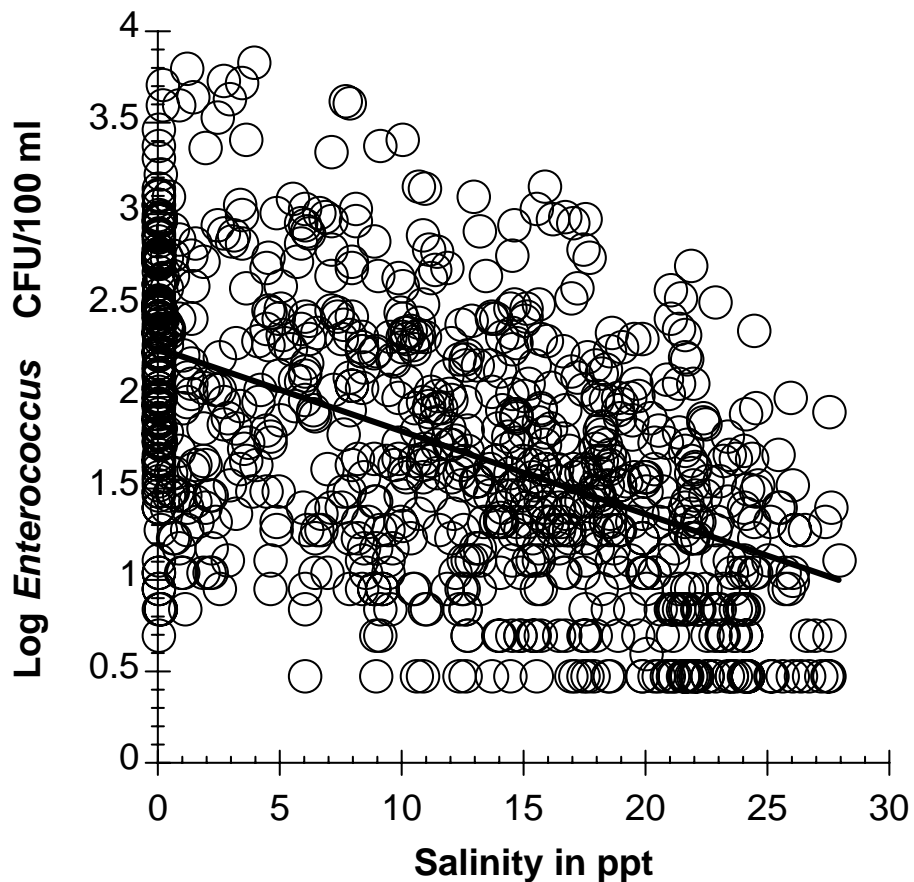
Figure 18. Conservative mixing analysis of *Enterococcus* in Bayou Chico.

A conservative mixing analysis of *Enterococcus* counts indicates a stronger freshwater origin for fecal contamination in this system (Figure 18), unlike Bayou Grande, where no relationship of fecal concentrations to salinity was observed.

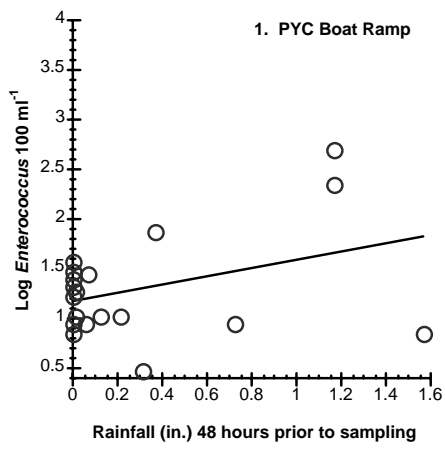
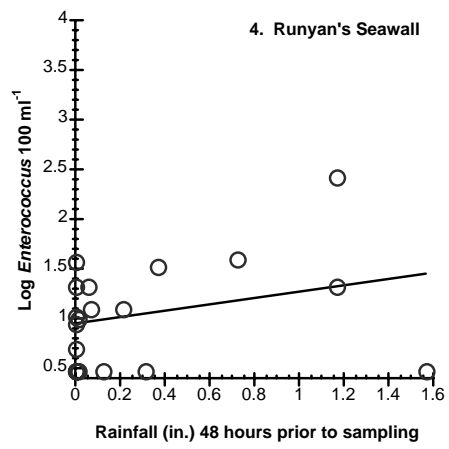
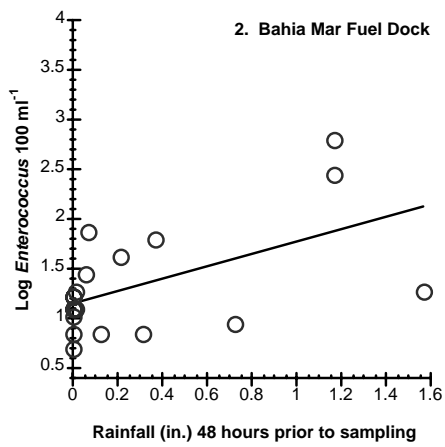
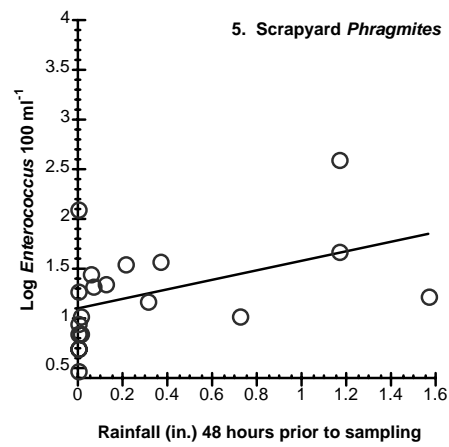
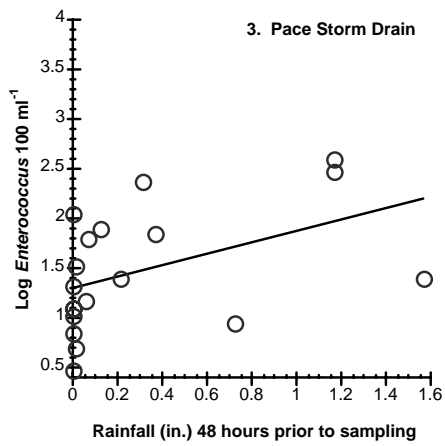
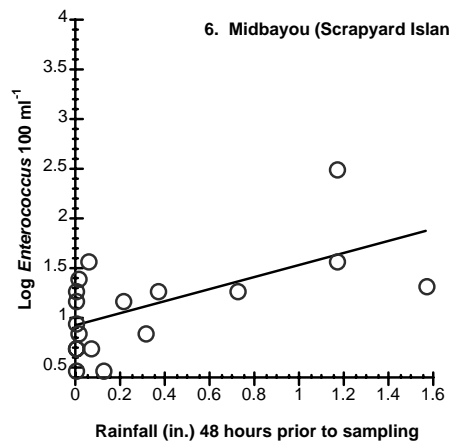
Figure 23. *Enterococcus* dependence on rainfall by station for Bayou Chico.

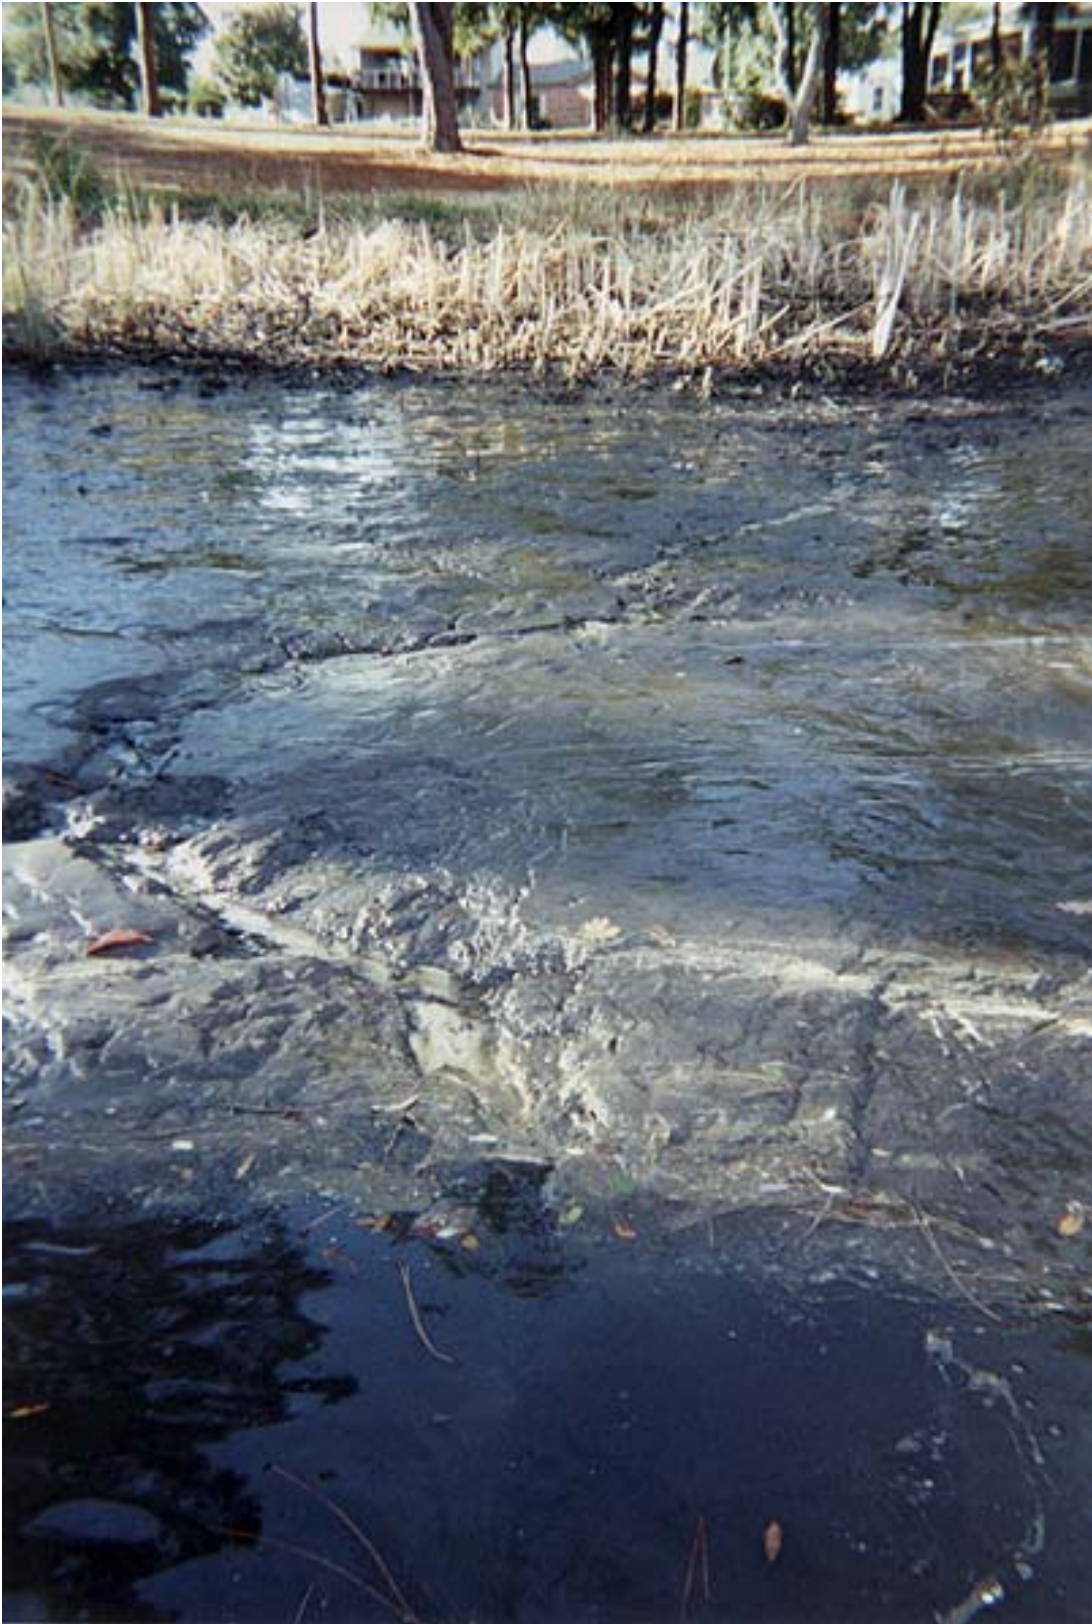
Figure 38. In the north arm of Bayou Grande, a ground water stream is pictured leaving the shoreline below the wetland vegetation under the high tide mark and traversing the intertidal zone.

In Bayou Grande, extreme low tides in the winter of 2001 were targeted for sampling exposed groundwater flows across the intertidal areas into Bayou Grande. These groundwater discharges were visible as streams flowing out of the shoreline across the intertidal zone (Figure 38), plumes of water emerging from invertebrate burrows under hydrostatic pressure, and as less well defined broad seepage areas emerging from the sands and muds of the intertidal zone. For Bayou Grande, sample locations were identified by eye, and by gauging the rate of fill (if any) in shallow (6-8") holes dug in the upper intertidal zone.
