INSPECTION REPORT
UWF EH&S

Inspection type: Water Intrusion & Odor Report No. 061212-B4 (S&E)
Inspector: Pennie Sparks Contact Information: (850) 474-2177 psparks@uwf.edu
Date: 06/11/12 Time: 10:30am & 4:00pm Facility: Building 4 Science & Engineering
Room: 1st Floor Lobby and Halo deck

Inspection type: Tile Issues Report No. 061712-B54 (Pool)
Inspector: Pennie Sparks Contact Information: (850) 474-2177 psparks@uwf.edu
Date: 06/27/12 Time: 9:00 am Facility: Building 73 Pool
Room: Pool deck

Inspection type: Safety Report No. IR10151201
Inspector: Pennie Sparks Contact Information: (850) 474-2177 psparks@uwf.edu
Date: 10/15/12 Time: 3:00 pm Facility: Building 13
Room: Outside

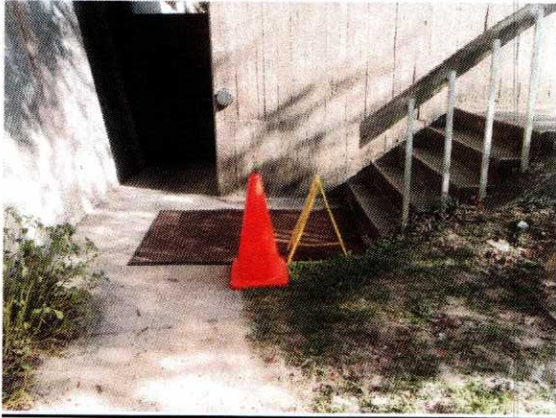
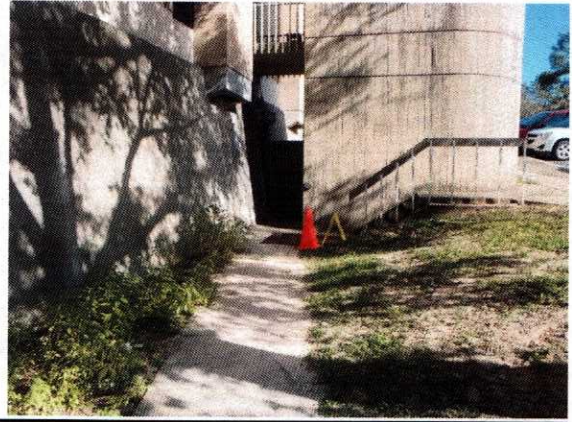
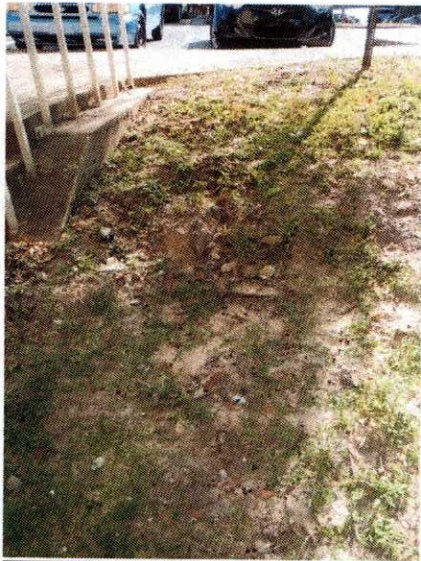
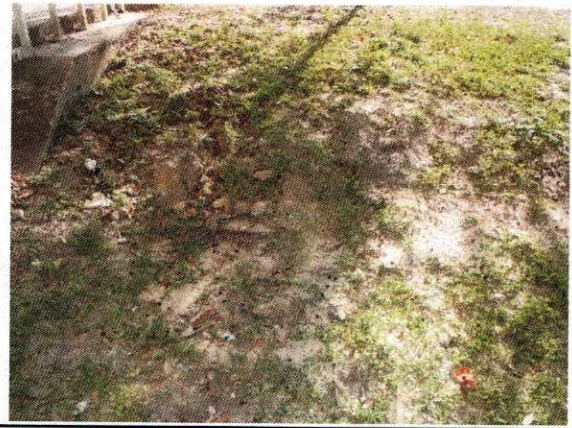
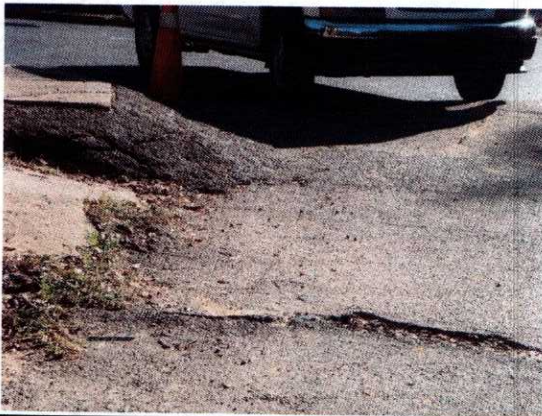
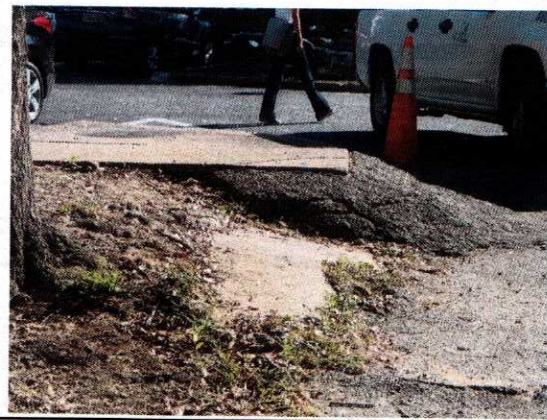
A possible safety issue was reported by a building occupant. The occupant described a washed out area under the sidewalk near the stairs that has created a large hole. They had placed a wet floor sign next to the area but not covering the hole. The area was surveyed, measured and photographed (see attached). A large orange hazard cone was placed over the hole and the wet floor sign was moved to the bottom of the stairs to warn of the danger. The hole is located at the corner of two sections of concrete at the bottom of the outside stairs leading to stairway 100C. It is approximately thirteen inches deep, eleven inches long and six inches wide. The soil is caving in on either side of the existing hole, which if not corrected will create an even bigger hazard to pedestrian traffic in the area.

The hill/slope next to the stairs and above the sidewalk is also eroding away with fairly deep ruts (see attached photo). This area appears to be heavily traveled and should be considered in the long term solution to the existing problems. Also, the entrance to the service road and the service road itself is in dire need of repair. The asphalt is mounded on the edge of the entrance and deep cracks exist in the asphalt. Since this road is used as a pedestrian pathway to access the nature trail by university faculty, staff, students and the public, it should be maintained to a satisfactory level of safety.
